Navajo Abandoned Uranium Mine

Site Screen Report

Cove Mesa Mines (AEC Plot 7) AUM Site

March 2010

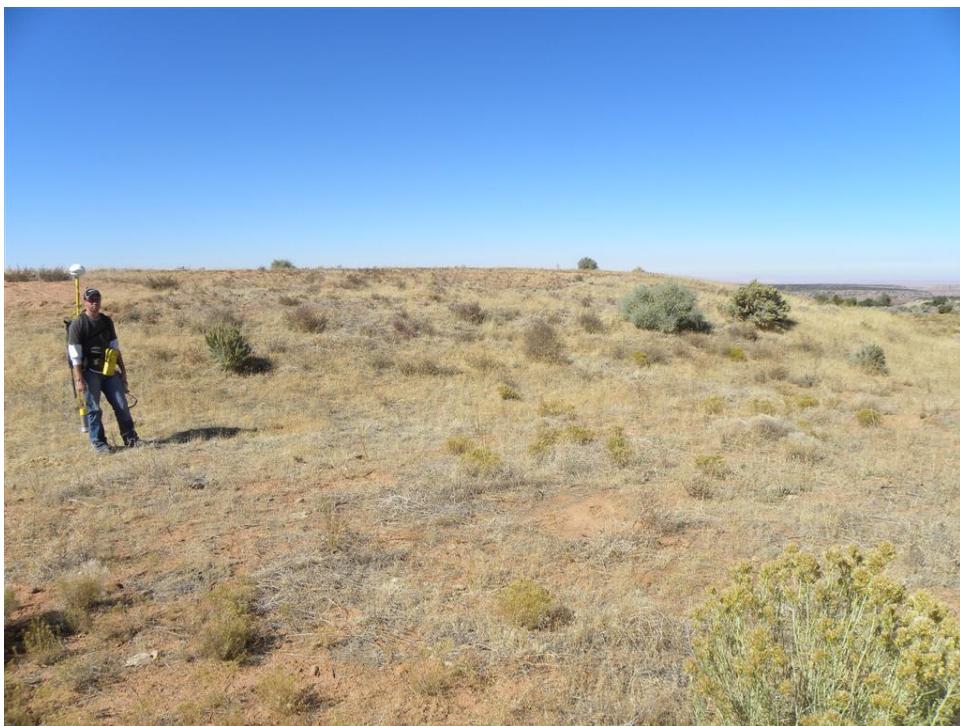
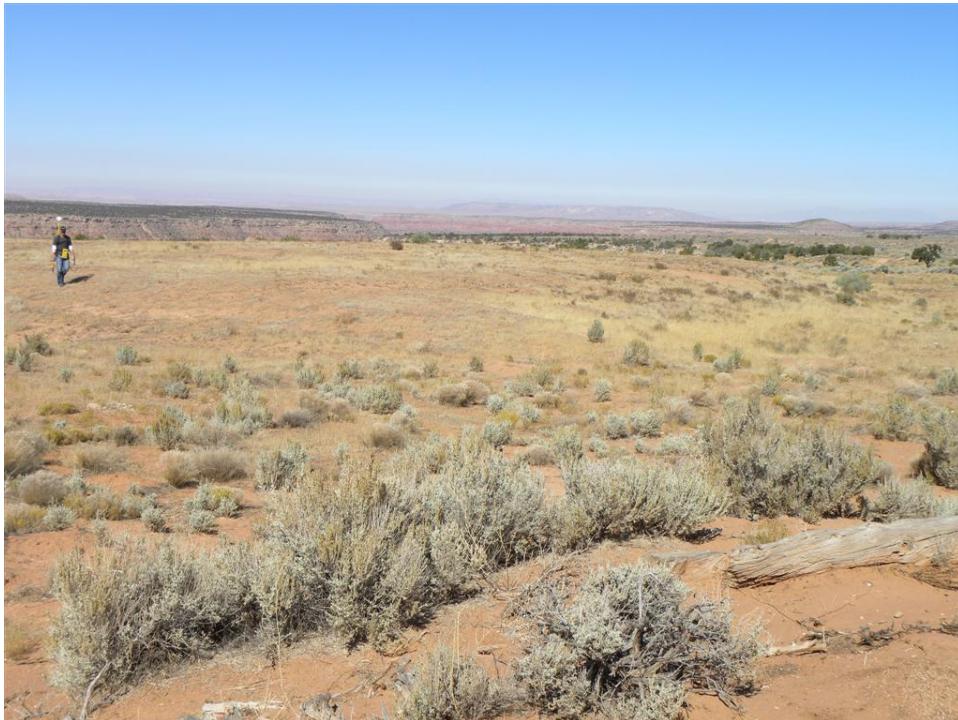
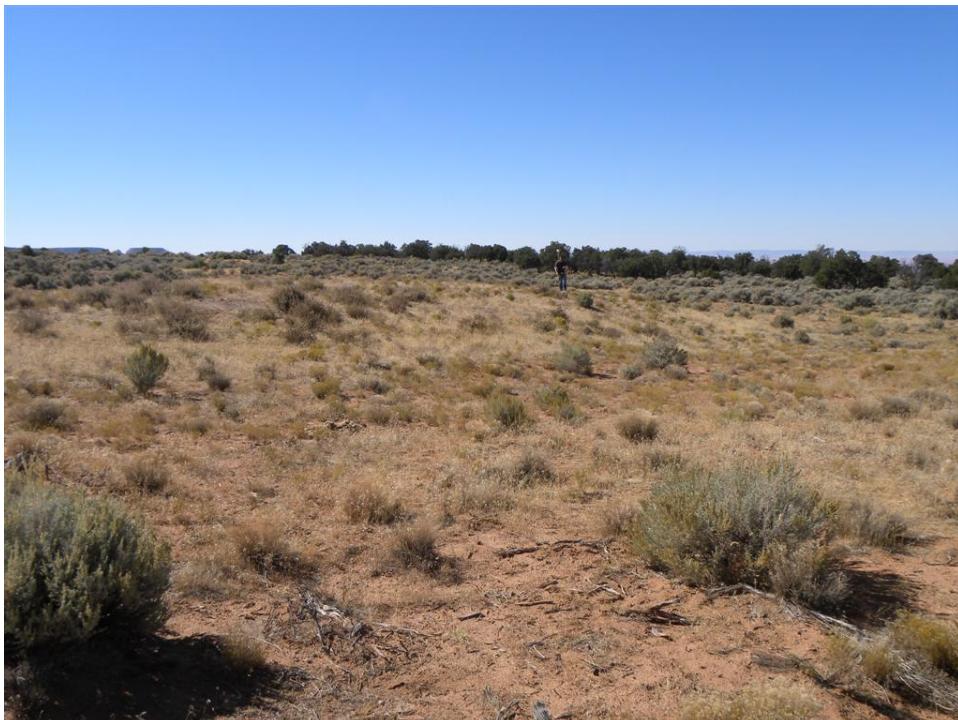
Photo 34. Site #501– Reclamation cap

Photo 35. Site #501– Reclamation cap

Photo 36. Site #501– Reclamation cap

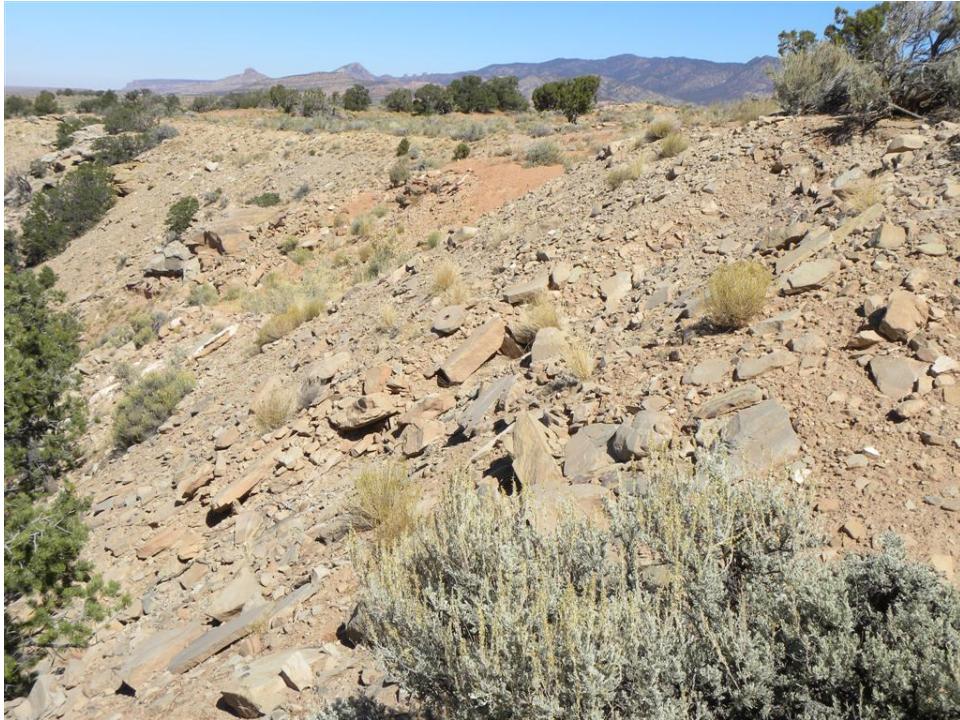
Photo 37. Site #501– Waste pile

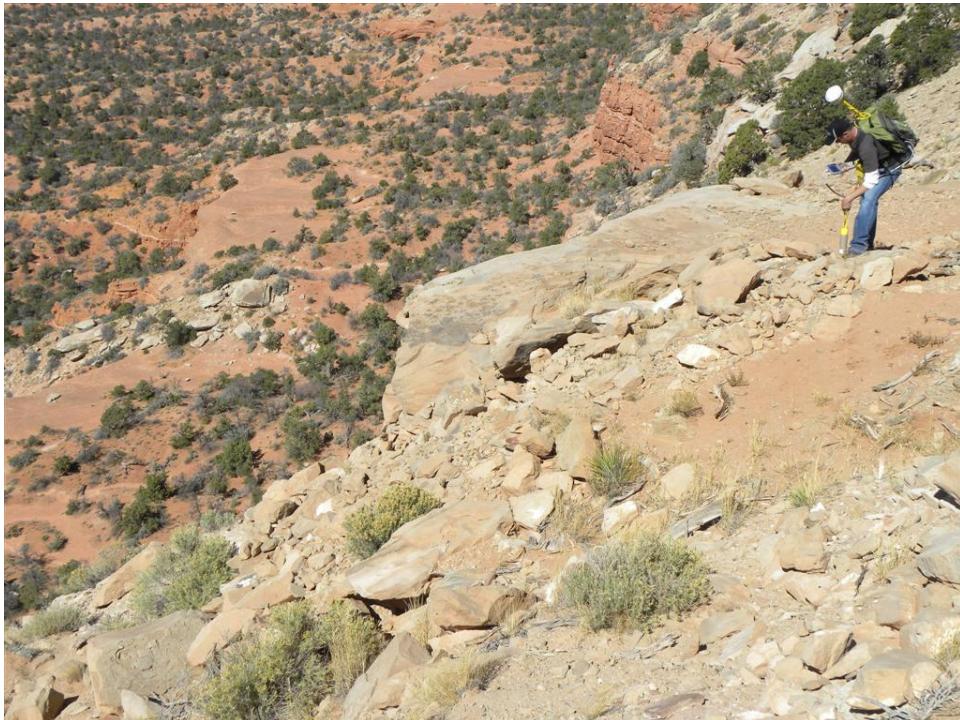
Photo 38. Site #501– Cliff area and waste rock

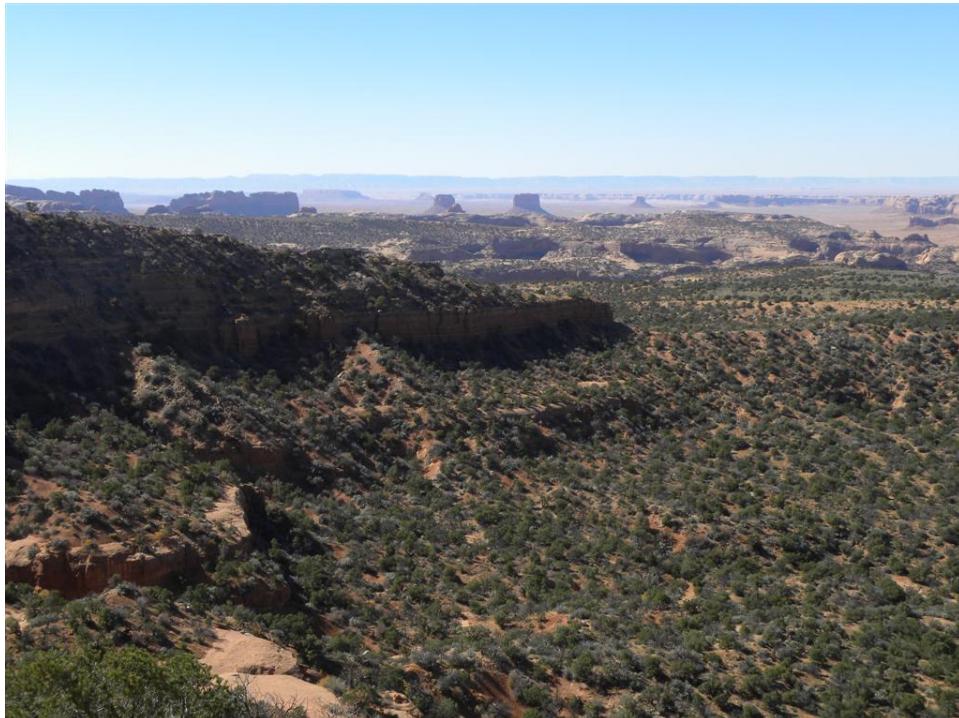
Photo 39. Site #501– Down slope area

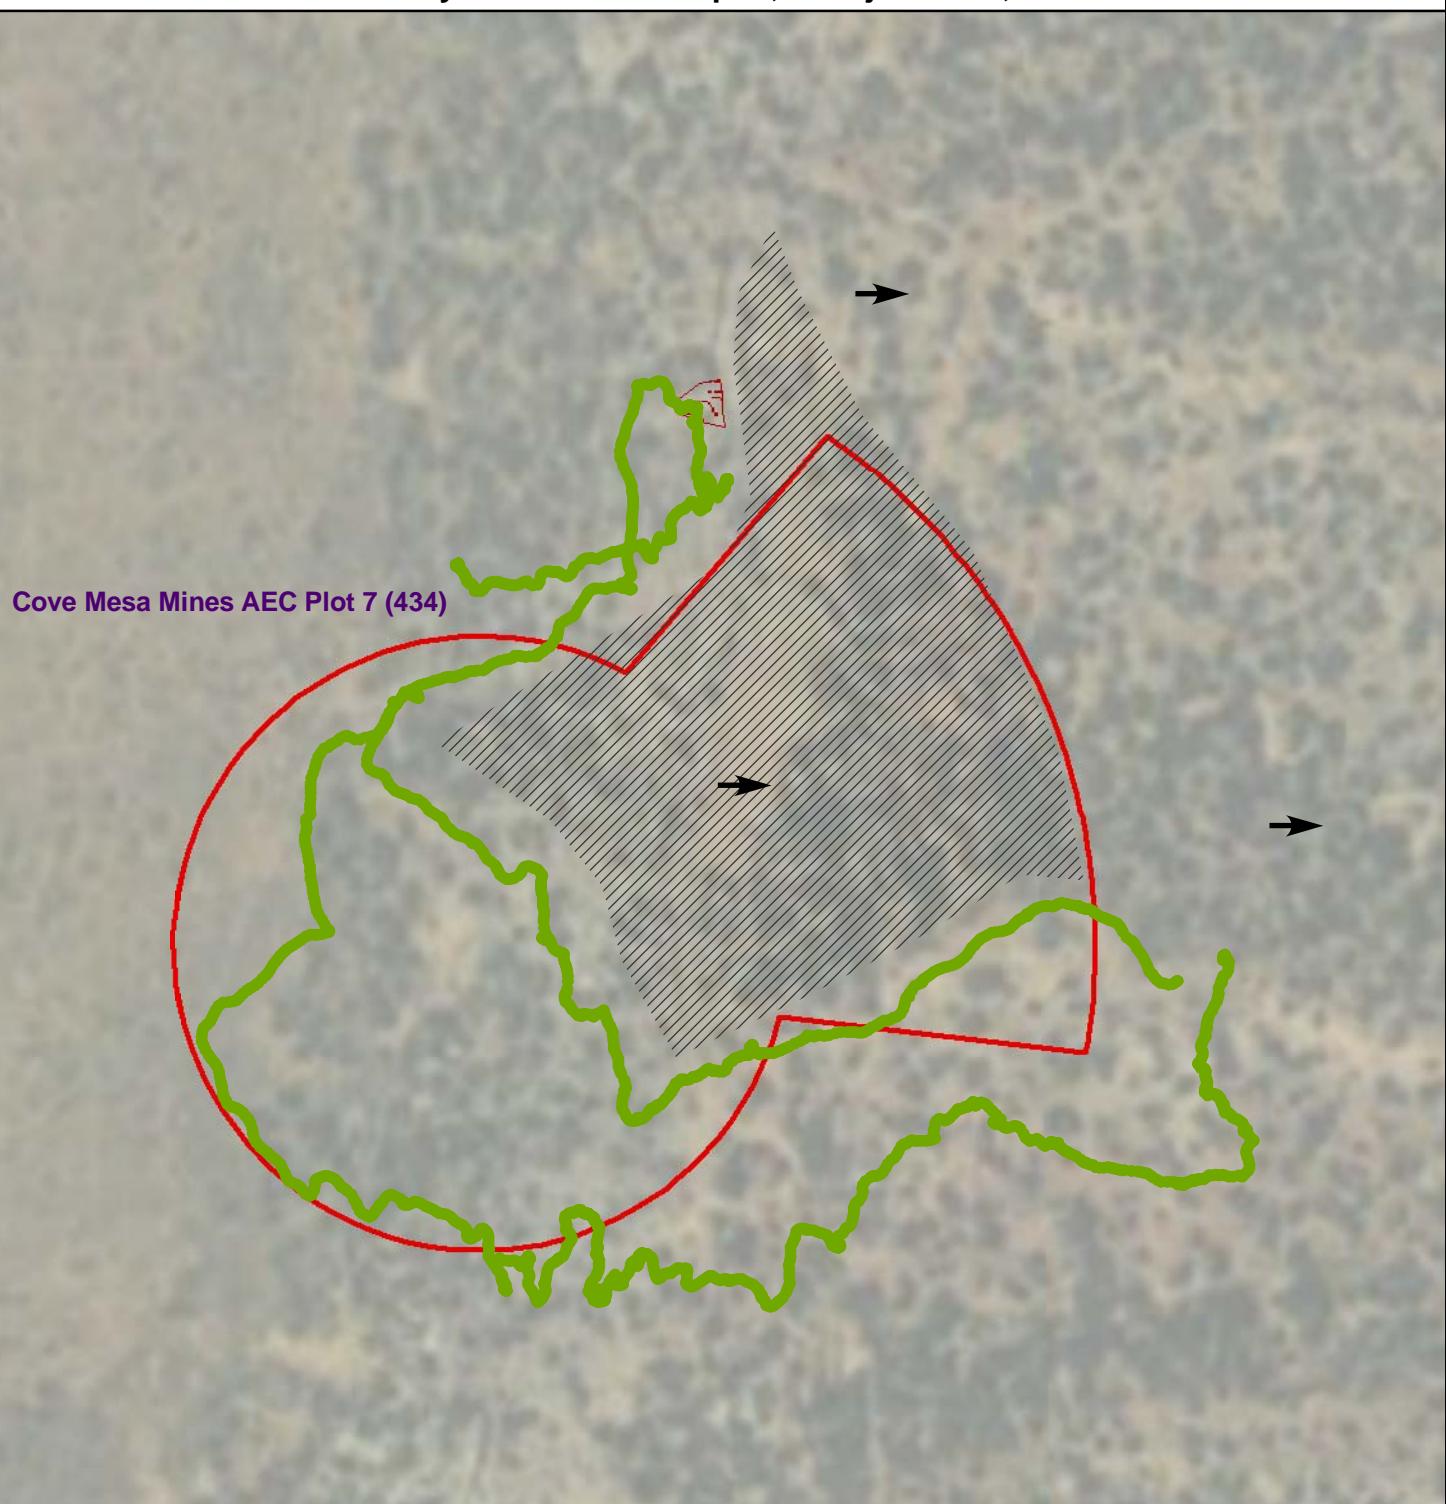
Figure 12 - Gamma Radiation Measurements, Above Two Times Background
Cove Mesa Mine AEC Plot 7 (434)
Red Valley/Sweetwater Chapter, Navajo Nation, Arizona

A total of 3,090 gamma radiation measurements were collected from the mine site, ranging from 6,266 cpm to 15,489 cpm. The measurements are represented in Figures 12 and 13.

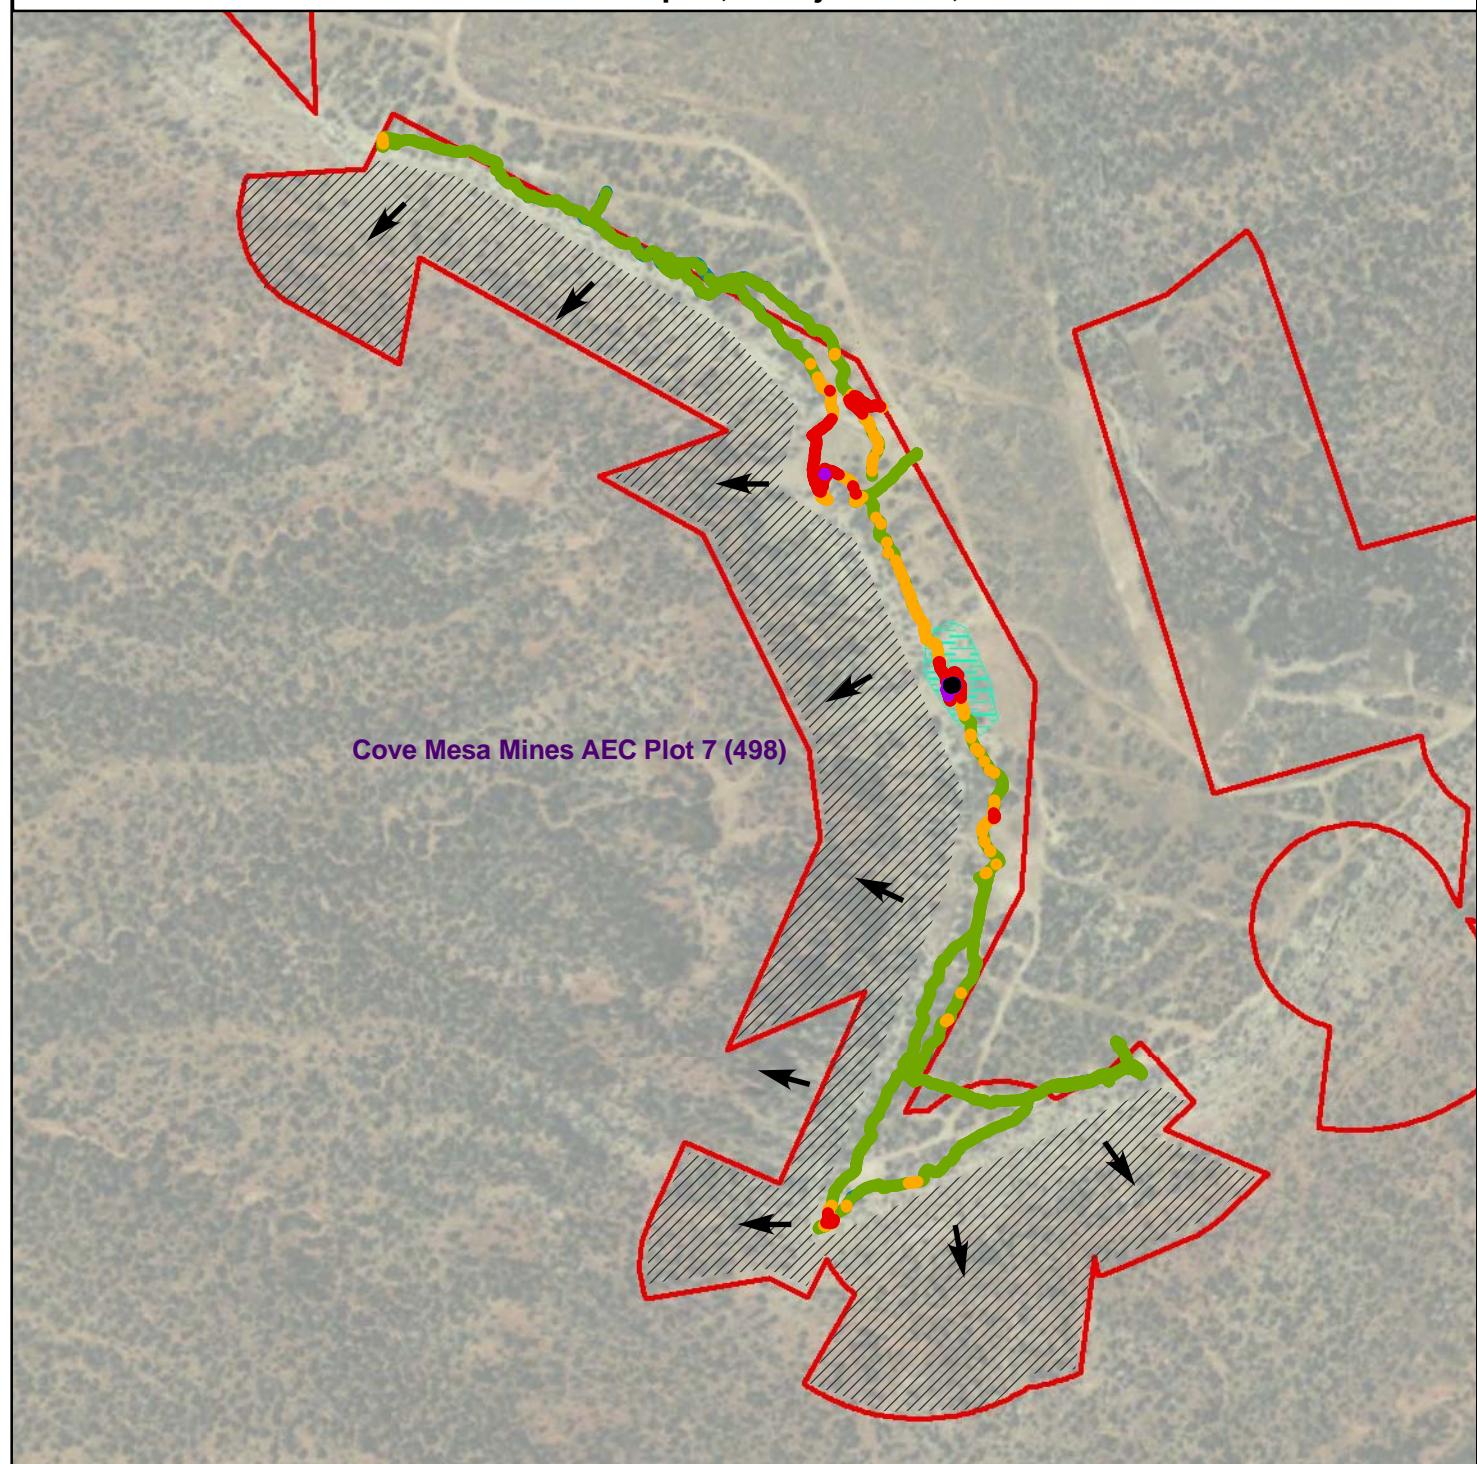
Figure 16 - Gamma Radiation Measurements, Above Two Times Background
Cove Mesa Mines AEC Plot 7 (498)
Sweetwater Chapter, Navajo Nation, Arizona

A total of 3,925 gamma radiation measurements were collected from the mine site, ranging from 8,056 cpm to 144,844 cpm. Measurements in the vicinity of the waste debris were found at levels of approximately 40,000 cpm. Measurements in the vicinity of the reclamation cap ranged from 80,000 cpm – 140,000 cpm. The measurements are represented in Figures 16 and 17.
